Research article

Structural Analysis of the Deck of a Deck-Cargo Barge using the Finite Element Method to Predict the Effects of Corrosion and Fatigue on Collapse Stress

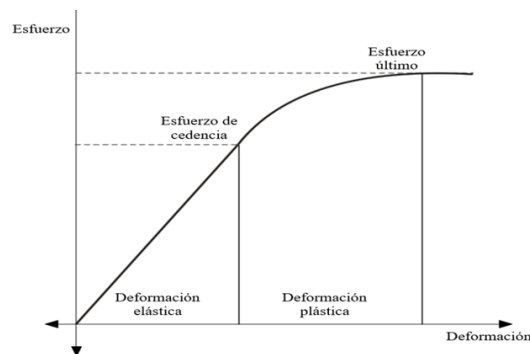
Figure 2. Elastoplastic behavior of a steel, Juárez O.M. (2011)
Source: The authors.

The dynamics of collapse are explained by the elastoplastic behavior of the material. To understand elastoplasticity, it is necessary to describe the elastic and plastic properties of a material, as well as the transition between the two zones. Therefore, the use of a material characterization graph is required, as is usual in engineering, where each material has distinctive properties. The curve that represents this behavior is obtained from experimental tests of simple tension, in which key points are identified that reveal the specific properties of the material, as shown in Figure 2. The yielding effort, which marks the limit of the elastic zone, is one of the most important points.

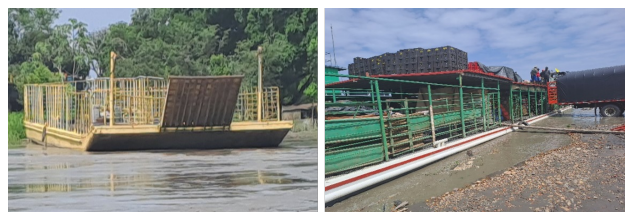
Figure 7. Typical barges operating on the Meta River
Source: The authors.

There are four types of barges, Table 1 shows the types of barges, and in Figure 7, you can see barges that operate in the Meta River waterway.

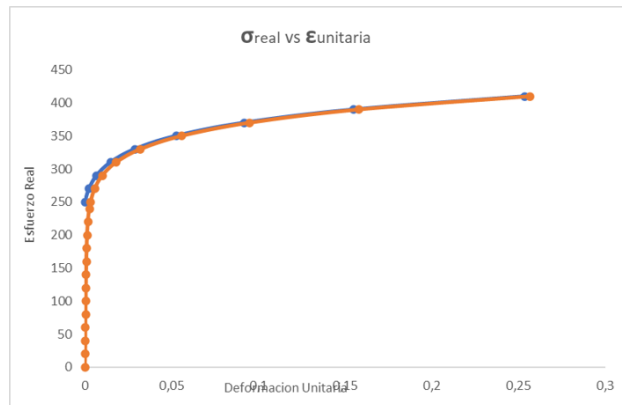
Figure 11. Graph of real stress vs unit strain

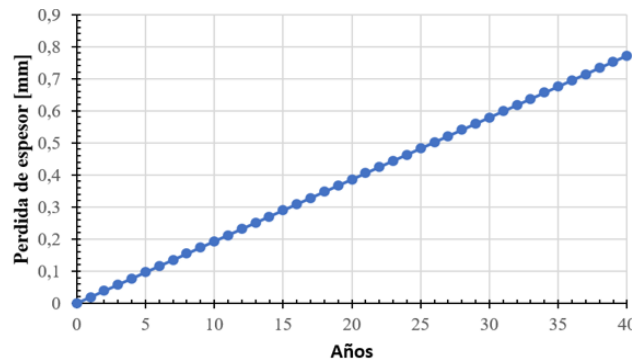
A thickness loss of 0.5 mm in the boat sheets is estimated over a period of 25 years. However, this rate could increase if additional factors such as river temperature, salinity levels, pollution, and the presence of certain types of bacteria are considered (see Figure 14).

Figure 14. Estimation of sheet thickness losses due to corrosion

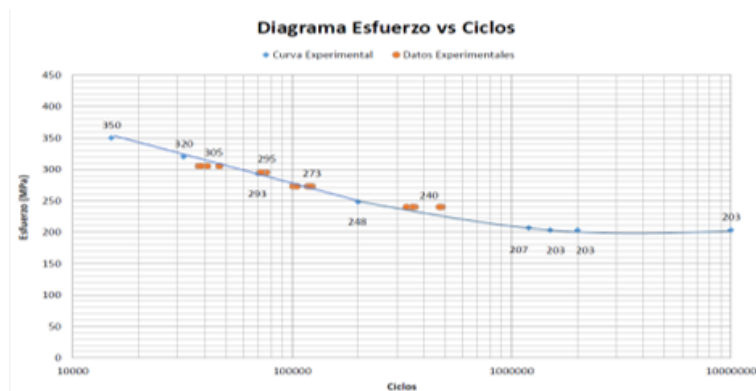
Figure 16. Curve S-N A36 steel.

The evaluation of the fatigue life of the material was carried out using the S-N curve for A-36 steel, using Goodman’s failure theory, a stress ratio of 0 and an amplitude ratio of 1.0. A loading pattern was defined based on the loading and unloading cycle of the barge (see Figure 39). Figures 15 and 16 show the S-N curves of A-36 steel.

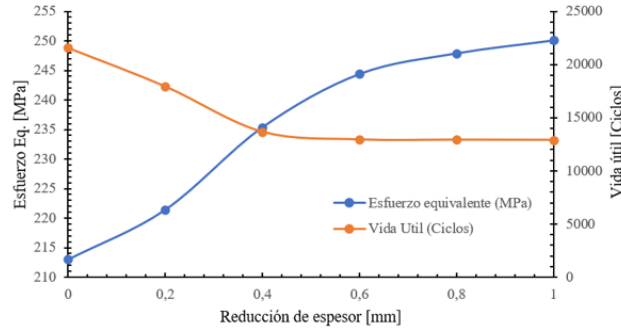
The study determines that the decrease in thickness has a significant impact on structural integrity. It was identified that for every millimeter of reduction in thickness, the equivalent Von Mises stress increases by 14%, indicating that the structure must withstand greater resilient demand in the face of loss of structural capacity. This reduction also has a negative impact on the service life of the barge, reducing it by approximately 9,000 cycles (see Figure 39).

Figure 39. Stress vs. Thickness Reduction & Stress vs. Tool Life
Source: The authors.
